## Mountain Lake

### *2016 Aquatic Vegetation Survey Report*

Liberty Township, NJ

## **Aquatic Vegetation Survey Report 2016**

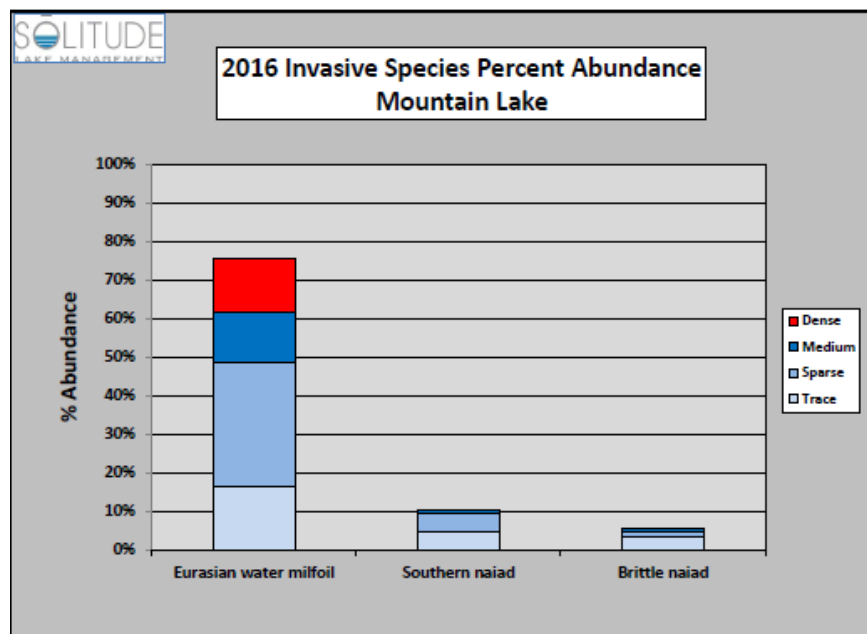
Figure 1. Mountain Lake 2016 Percent Abundance of Invasive Aquatic Macrophyte Species.

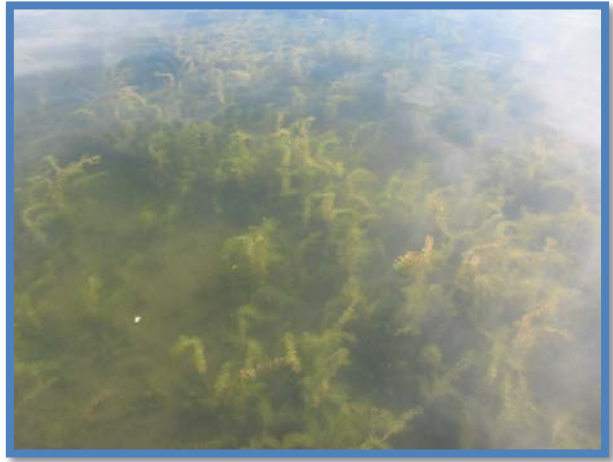
Eurasian water milfoil was the dominant aquatic macrophyte collected in 2016, and been the target of control throughout the basin. Eurasian water milfoil occurred at 64 (or 75%) of the sites surveyed. Most of the Eurasian water milfoil was observed at nuisance level (medium or dense) densities; 19% of the sites that had Eurasian water milfoil were observed at dense abundances and 17% of the sites contained medium abundances. At 27 sites (or 42%) we observed sparse Eurasian water milfoil, while at 14 sites (or 22%) we observed trace abundances. The majority of the Eurasian water milfoil was observed along all shorelines of Mountain Lake. As shown in the picture is a typical bed of Eurasian water milfoil observed at Mountain Lake.

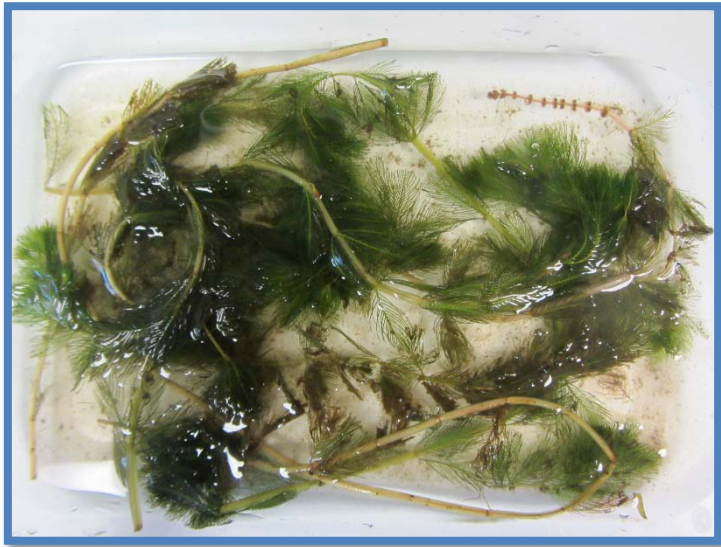
Eurasian water milfoil has long (2 meters or more) spaghetti-like stems that grow from submerged rhizomes. The stems often branch repeatedly at the water's surface creating a canopy that can crowd out other vegetation, and obstruct recreation and navigation. The leaves are arranged in whorls of 4 to 5, and spread out along the stem. The leaves are divided like a feather,

resembling the bones on a fish spine. Eurasian water milfoil is an exotic originating in Europe and Asia, but its range now includes most of the United States. It's ability to grow in cool water and at low light conditions gives it an early season advantage over other native submersed plants. In addition to reproducing via fruit production, it can also reproduce via fragmentation. Waterfowl graze on Eurasian water milfoil, and its vegetation provides habitat for invertebrates. However, studies have determined mixed beds of pondweeds and wild celery can support more diverse invertebrate populations

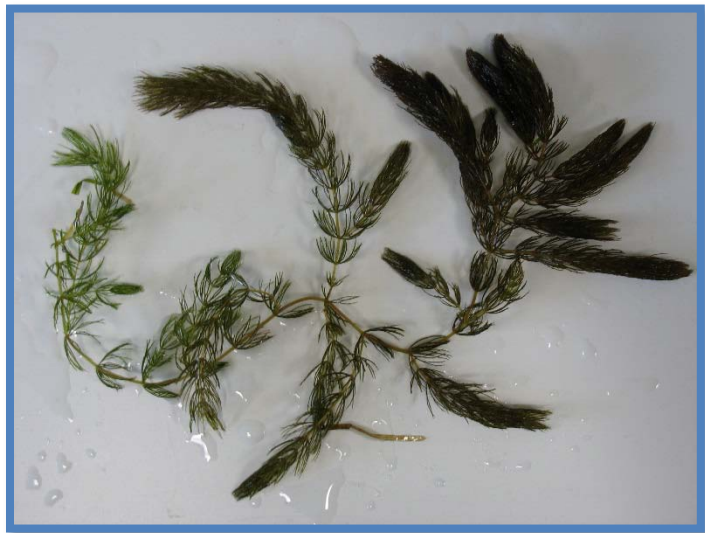
### **Coontail** (*Ceratophyllum demersum*.

**Native.**): Coontail has long trailing stems that lack true roots, although it can become loosely anchored to sediment by modified

leaves. The leaves are stiff, and arranged in whorls of 5-12 at each node. Each leaf is forked once or twice, and has teeth along the margins. The whorls of leaves are spaced closer at the end of the stem, creating a raccoon tail appearance. Coontail is tolerant of low light conditions, and since it is not rooted,

it can drift into different depth zones. Coontail can also tolerate cool water and can over winter as a green plant under the ice. Typically, it reproduces via fragmentation. Bushy stems of

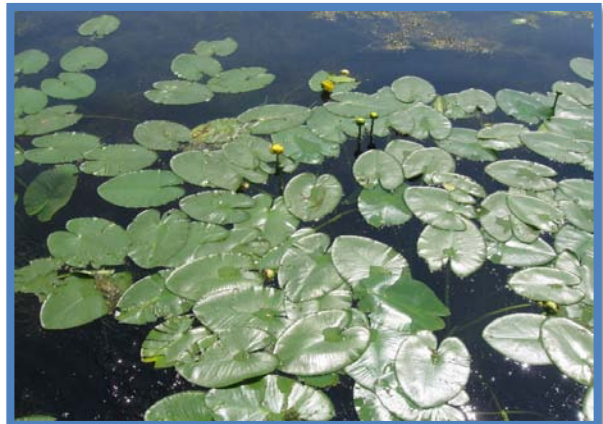
**Native**.): Spatterdock leaf stalks emergedirectly

from a submerged fleshy rhizome. The leaf stalk has a winged margin, which is a distinguishing characteristic. Spatterdock has heart-shaped leaves with a prominent notch. Flowers are globular in shape with five to six yellow sepals. Flowering occurs in the summer and the flowers open during the day and close at night. Water lilies typically inhabit quiet water less than two meters deep, such as ponds, shallow lakes and

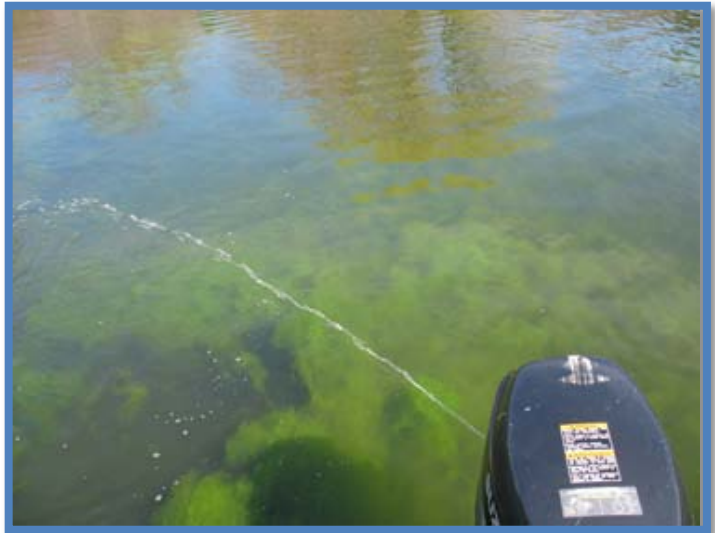
### **Benthic and Floating Filamentous Algae**

Filamentous algae is a chain or series of similar algae cells arranged in an end to end manner. Benthic filamentous algae is attached to a hard substrate, such as logs, rocks, a lake bottom, or even other aquatic plants. When growing in heavy densities, benthic filamentous algae can appear as brown or green mats of vegetation that can reach the surface. When large pieces break off the bottom substrate they become floating filamentous algae patches. Benthic filamentous algae can comprise an entire range of morphologies, but flagellated taxa are far less common.

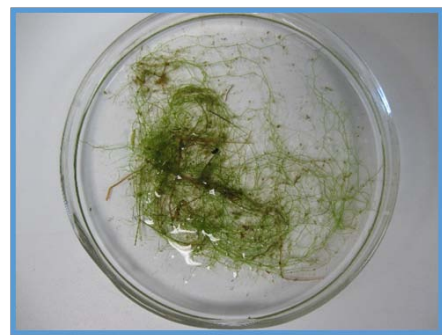
**Creeping Bladderwort** (*Utricularia gibba*. Common Names: creeping bladderwort, humped bladderwort, cone-spur bladderwort. **Native**.). Creeping bladderwort is a small (usually less than 10 cm long), delicate, free-floating stem. It often forms tangled mats in quiet shallow waters, often associated with bogs, or stranded on soil. It is sometimes mistaken for algae. It has short side branches that fork once or twice, a defining characteristic. Small bladders, used to capture live prey, are situated on these

side branches. Small yellow snap-dragon-like flowers are produced on a short stalk. Mats of creeping bladderwort offer limited cover and foraging opportunities for fish.

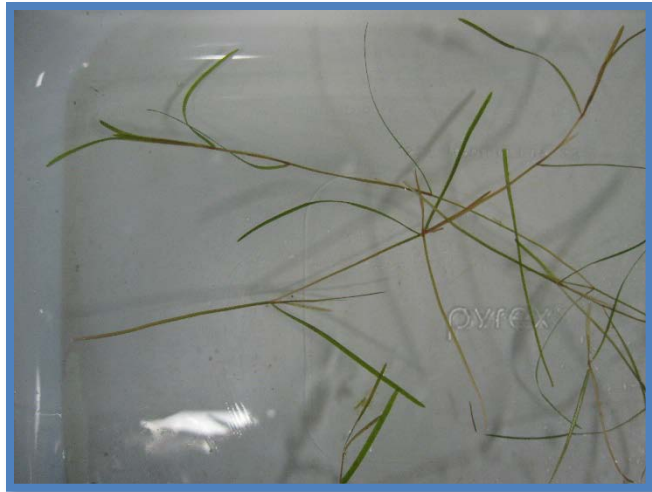
**Leafy Pondweed** (*Potamogeton foliosus*:

**Native.**): Leafy pondweed has freely branched stems that hold slender submersed leaves that become slightly more narrow as they approach the stem. The leaf contains 3-5 veins and often tapers to a point. No floating leaves are produced. It produces early season fruits in tight clusters on short stalks in the leaf axils. These early season fruits are often the first grazed upon by waterfowl during the season. Muskrat, beaver, deer and even moose also graze on the fruit. It

inhabits a wide range of habitats, but usually prefers shallow water. It has a high tolerance for eutrophic conditions, allowing it to even colonize secondary water treatment ponds.

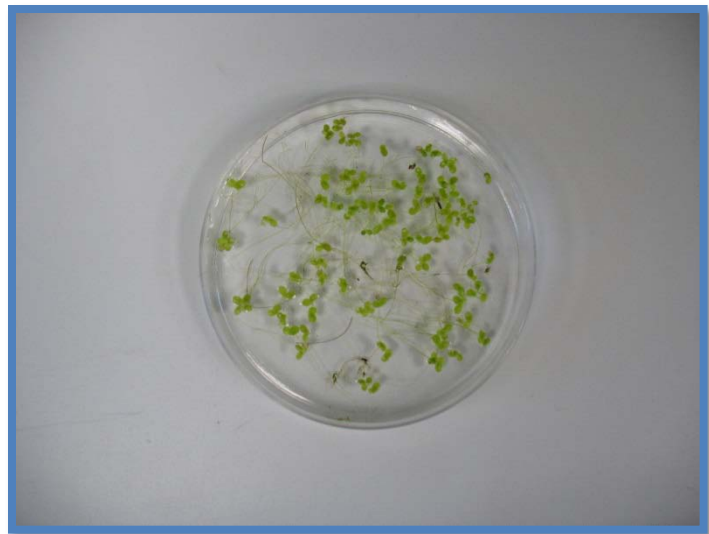
**Small Duckweed** (*Lemna minor*.

Small duckweed is a free floating plant, with round to oval-shaped leaf bodies typically referred to as fronds. The fronds are small (typically less than 0.5 cm in diameter), and it can occur in large densities that can create a dense mat on the water's surface. Each frond contains three faint nerves, a single root (a characteristic used to distinguish it from other duckweeds), and no stem. Although it can produce flowers, it usually reproduces via

budding at a tremendous rate. Its population can double in three to five days. Since it is free floating, it drifts with the wind or water current, and is often found intermixed with other duckweeds. Since it's not attached to the sediment, it derives nutrients directly from the water, and is often associated with eutrophic conditions. It over winters by producing turions late in the season. Small duckweed is extremely nutritious and can provide up to 90% of the dietary needs for waterfowl. It's also consumed by muskrat, beaver and fish, and dense mats of duckweed can actually inhibit mosquito breeding.

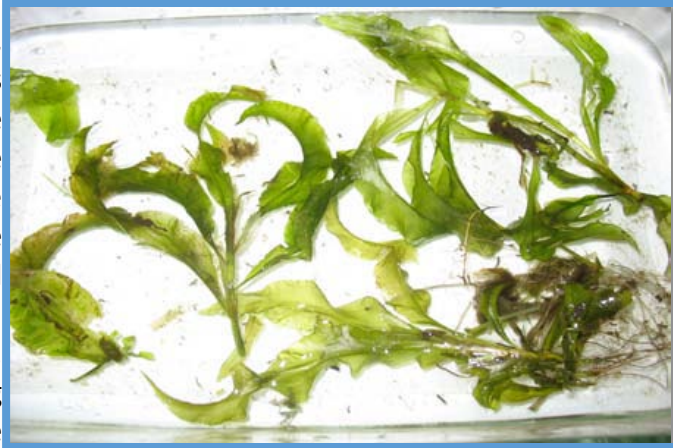
**Bass Weed** (*Potamogeton amplifolius*.

Common Names: Large-leaf Pondweed, Bass Weed, Musky Weed. **Native.**): Bass weed has robust stems that originate from black-scaled rhizomes. The submersed leaves of bass weed are among the broadest in the region. The submersed leaves are arched and slightly folded, attached to stems via stalks, and possess many (25-37 veins). Floating leaves are produced on long stalks (8-30 cm). Stipules are large, free and taper to a sharp point. Flowers, and

later in the season fruit are densely packed onto a spike. Bass weed prefers soft sediments in water one to 4 meters deep. This plant is sensitive to increased turbidity and also has difficulty recovering from top-cutting, from such devices as boat propellers and aquatic plant harvesters. As its name implies the broad leaves of this submersed plant provides abundant shade, shelter and foraging opportunities for fish. The high number of nutlets produced per plant makes it an excellent waterfowl food source.

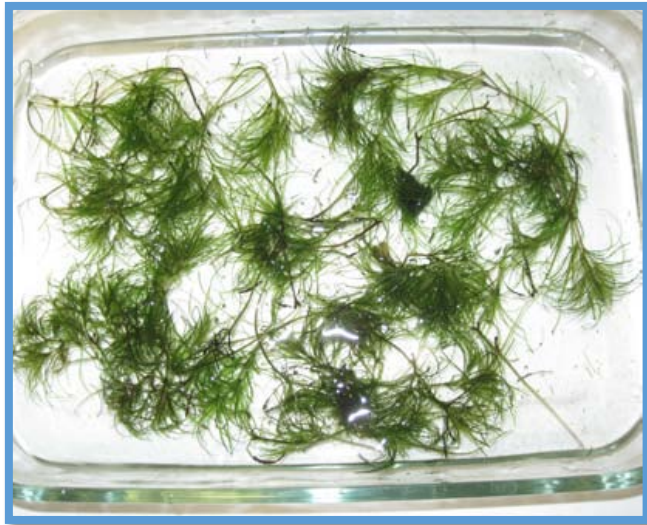
**Brittle Naiad** (*Najas minor*. Common

Names: brittle water nymph, European naiad. **Exotic, Invasive**): Brittle naiad is a submersed annual that flowers in August to October. It resembles other naiads, except its leaves are highly toothed with 6-15 spinules on each side of the leaf, visible without the aid of magnification. The leaves are opposite, simple, thread-like, and usually lime-green in color, often with a “brittle” feel to them. Brittle naiad fruit are narrow, slightly curved, and marked with 10-18 longitudinal ribs, resembling a ladder. Brittle Naiad has been introduced from Europe in the early

1900's, and can be found in most of the northeastern states. Brittle naiad prefers sandy and gravel substrates, but can tolerate a wide range of bottom types. It's tolerant of turbid and eutrophic conditions. Waterfowl graze on the fruit.

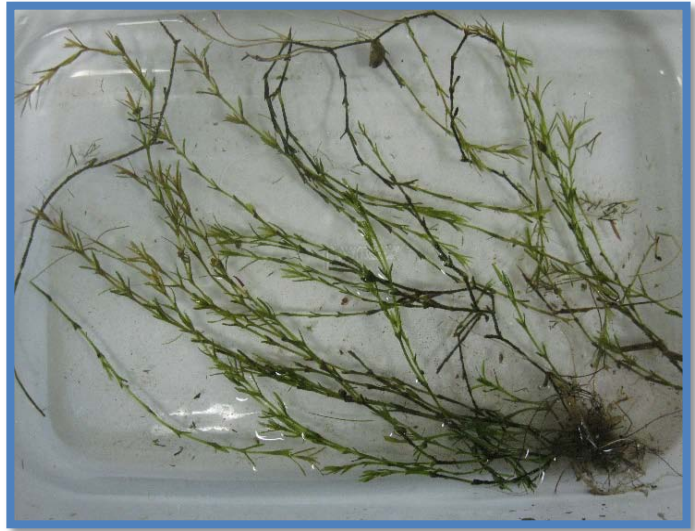
**Southern Naiad** (*Najas guadalupensis*. Common Names: Southern water nymph, bushy pondweed. **Native.**): Southern naiad is an annual aquatic plant that can form dense stands of rooted vegetation. Its ribbon-like leaves are dark-green to greenish-purple, and are wider and less pointed than slender naiad. Flowers occur at the base of the leaves, but are so small; they usually require magnification to detect. Southern naiad is widely distributed, but is less common than slender naiad in northern zones. Southern naiad reproduces by seeds and fragmentation.

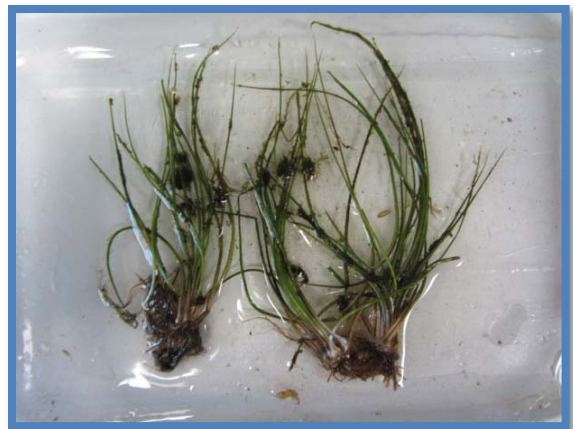
**Lake Quillwort** (*Isoetes lacustris*, = *I. macrospora*.

Common Name: Quillwort. **Native.**): Lake quillwort leaves grow from a fleshy, lobed underground stem adorned with forked roots. The green, often firm, leaves are arranged in a rosette, radiating from the base of the plant. Each leaf has a central vein and four longitudinal air chambers visible in cross-section. Spores form inside sacks located on the spoon-like bases of the leaves. Examining the megaspores is required to positively identify quillworts to species. Lake quillwort has pale unspotted spore sacks, and the megaspores have a convoluted network of ridges on their surface. Lake quillwort usually inhabits quiet lake waters ranging from a few centimeters deep to 1 to 3 meters deep. Most species of quillwort prefer low-nutrient, soft water habitats. Quillwort foliage is sometimes consumed by waterfowl.

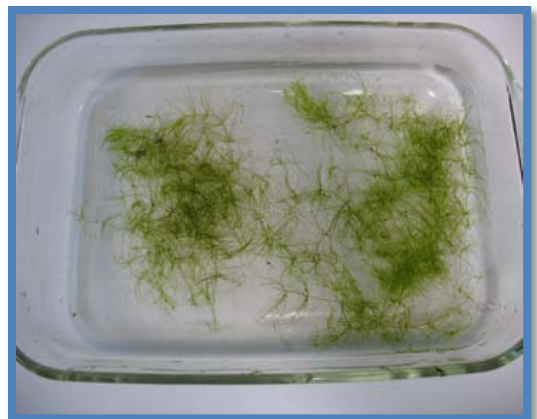
**Muskgrass** (*Chara* sp. Common Names: muskgrass, stonewort, chara. **Native.**): Chara is actually a multi-branched algae that appears as a higher plant. It is simple in structure and has rhizoids instead of true roots. The branches of chara have ridges that are often encrusted with calcium carbonate. This grants the entire plant a "crusty" feel and appearance. The side branches develop in whorls that look like the spoke in a wheel. Chara is easily identified by a pungent, skunky odor. It prefers softer sediments, and can often be found in deeper water than other

plants. As such, it's considered an early pioneer, the first species to colonize a disturbed lakebed.

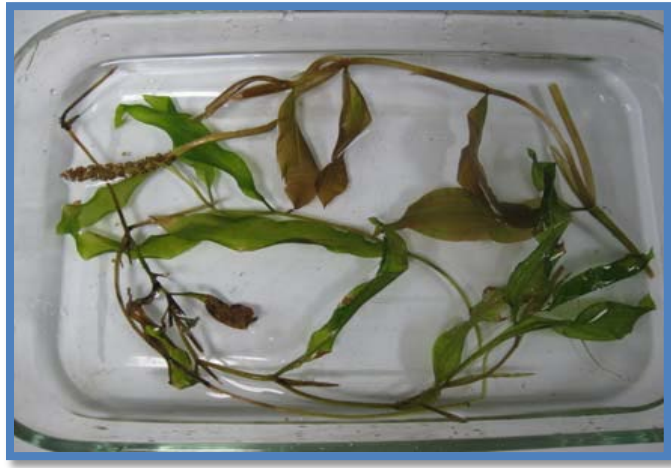
**Illinois Pondweed** (*Potamogeton illinoensis*. Common Name: Illinois pondweed. **Native**). Illinois pondweed has stout stems up to 2 meters long that emerge from thick rhizomes. The submerged leaves are lance-shaped with a needlelike point, attached directly to the stem or on a short stalk. The stipules are free, and have two prominent ridges called keels. Sometimes ellipse shaped floating leaves are produced on a thick stalk usually shorter than the blade. Flower and fruit are arranged in a tight

cylindrical spike on a stalk thicker than the stem. It tends to grow in shallow water up to depths of 3 meters, and prefers water with high clarity. Illinois pondweed fruit is valuable as waterfowl food, and the large leaves create suitable shade and cover for many fish and invertebrates.
